CONTENTS

Pre-Construction and Post Construction Occupancy Counts

Moseley Architects “Final Report” dated February, 2020

Moseley Architects was retained by Nash County in November of 2019 to perform a Detention Center Expansion Needs Assessment service for the Nash County Detention Center. Services included evaluating the jail needs for a 20-year projection forecast, evaluate the existing facility and recommend repair, replacement, renovations as observed, develop expansion options with estimated costs, and present the findings to the County.

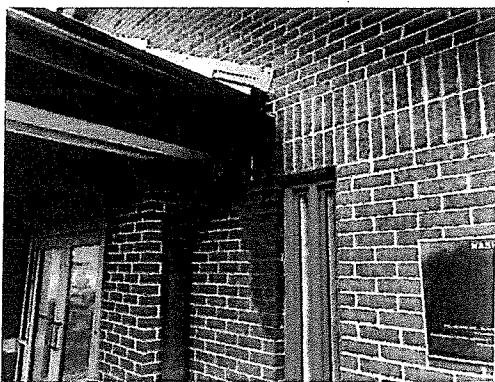
Photograph #1

- It was raining heavily at the time of this observation. Water was observed to be leaking from the roof gutter end located near the front entrance to the facility and running down the face of the exterior wall near a window. This could be representative of a problem with the gutter end cap and/or a clogged gutter. (Photo #1)

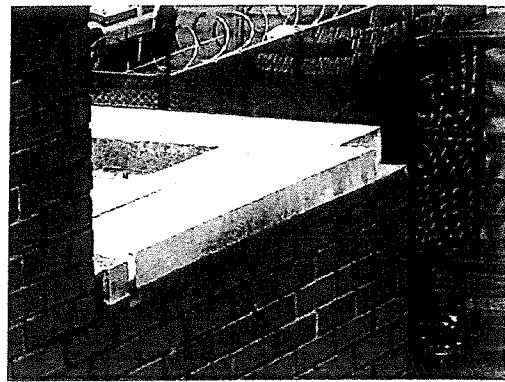
Photograph #2

- A portion of coping cap was missing at the rear of the building near the loading dock. It is unknown if this is causing any water infiltration issues into the building near this area. (Photo #2)

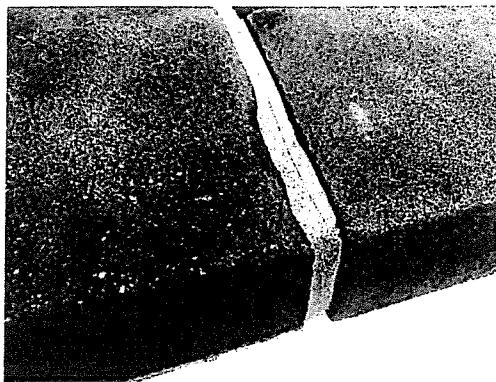
Photograph #3

- The sealant at the wall coping cap joints is deteriorating and separating from the masonry. It is unknown if this is causing any water infiltration issues into the building. The sealant should be replaced. (Photo #3)

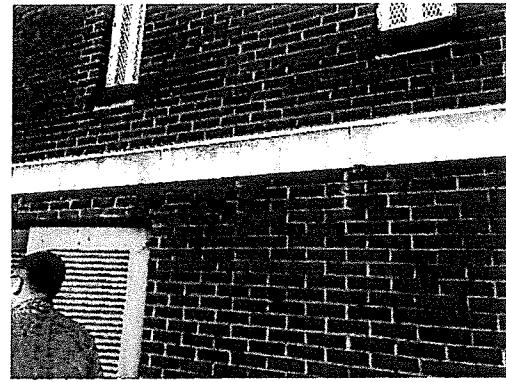
Photograph #4

- Cracking in the exterior brick near the door to the basement at the 1970's era building was observed. Brick in this area was out of alignment and pulling away from the building. Some of the brick has cracked and portions were observed with large chips. Mortar was missing from brick joints in this area. Areas above this location were observed where brick mortar joints appear to have previously been re-pointed. It is unknown if the cracking in this area is isolated to the exterior brick or if has translated through the exterior wall and is expressing on the interior of the building. This area needs further investigation to evaluate the problem. (Photo #4)

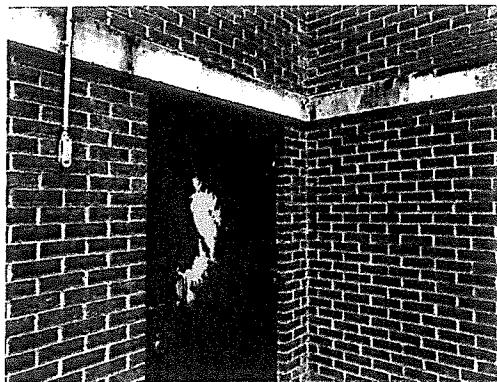
Photograph #5

- Exterior masonry in the outdoor recreation yard behind housing units #1 through #4 was observed to be very dirty and stained. This is likely due to water run-off from the security

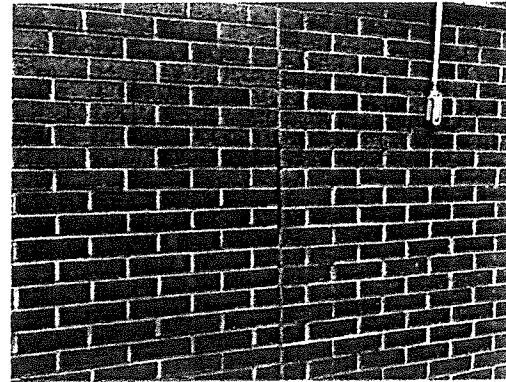
Photograph #6

- A portion of exterior sealant at the brick veneer control joint in this same rec yard was observed to be missing and needs to be replaced. The existing sealant should be removed along the entire height of the joint, and security pick-resistant sealant designed for use in detention environments, should be utilized. (Photo #6)

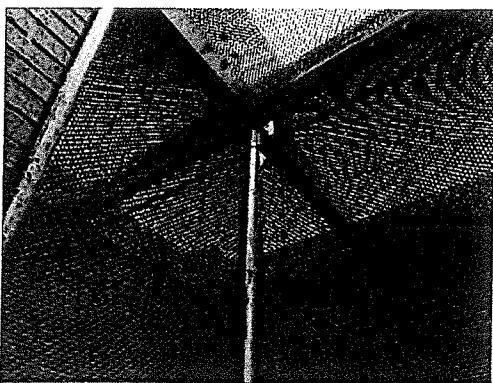
Photograph #7

- At this same rec yard behind housing units #1 through #3, an opening in the security wire fabric was observed at one location. (Photo #7) At another location there appears to be two sections of fabric that have been overlapped at a joint in the material. (Photo #8) It is unknown if this overlapped fabric is mechanically fastened in any way to the structure below or if it has been loose-laid only. During this walk-through, it was reported by the Sheriff's staff that this rec yard was the location of a security breach where two inmates recently escaped. County maintenance reported recent improvement to this area including the addition of a steel member along the bottom edge to secure the material. The overhead support structure needs to be repainted. Further evaluation of the security wire fabric needs to be completed in order to adequately evaluate the product/ system for the installed application. At a minimum, existing holes in the material needs to be repaired immediately to prevent further breaching.

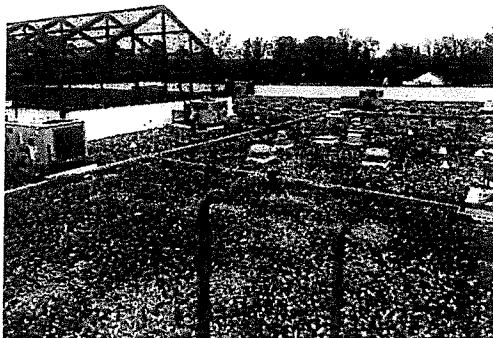
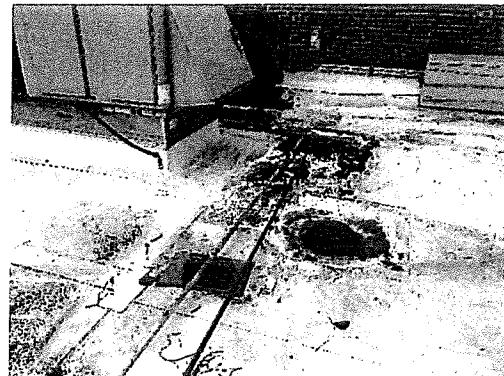
- The roof of the facility is a single-ply membrane which appears to be recently installed and is in relatively good shape. The 1970's era portion of the building is a ballasted roof system. It is unknown if this section of roofing is a different age than the rest or why this section only is ballasted. In general, the roof membrane is very dirty and needs cleaning. Since it was a heavy rain at the time of this observation, there were some small areas of ponding observed but nothing overly concerning. Some of the roof drain strainers were rusty and one was broken. At another roof drain location, debris has collected around the strainer causing some ponding. All debris should be removed, and the membrane properly cleaned. (Photos #9 and #10)

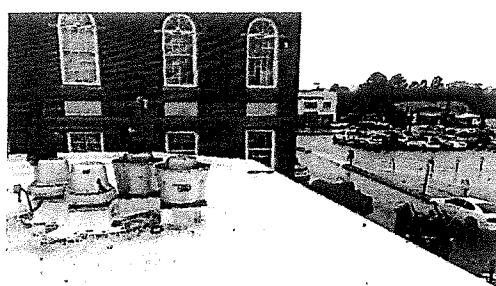
Photograph #11

- At the roof over housing units #4 and #5, mechanical equipment was observed to be very close to the edge of the roof. This section of the building does not have a parapet at the perimeter exterior wall. The building code requires a guardrail be installed if mechanical equipment is within 10 feet of a roof edge. Guards are likely required at this area. (Photo #11)

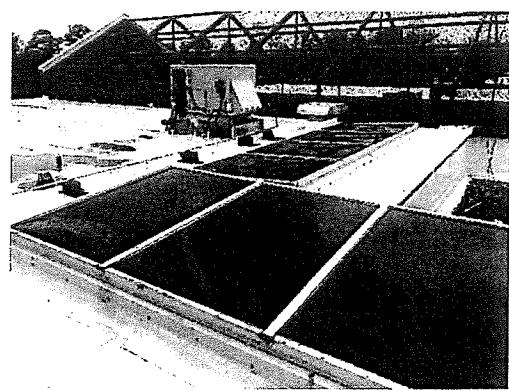
Photograph #12

- At this same area of roof, skylights are located over areas of corridor below. Glazing at these skylights appear to be nearing end of life. (Photo #12)

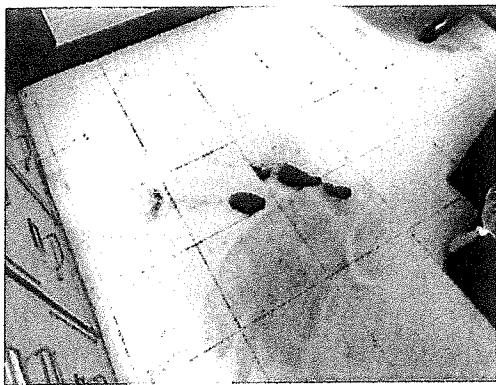
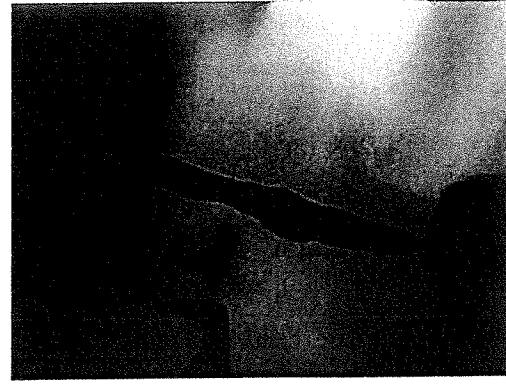
- Vinyl composition tile (VCT) has been utilized in most of the administrative areas and shows signs of wear. VCT in the control rooms and booking room have been worn down to the substrate below and should be replaced. (Photos #13 and #14)

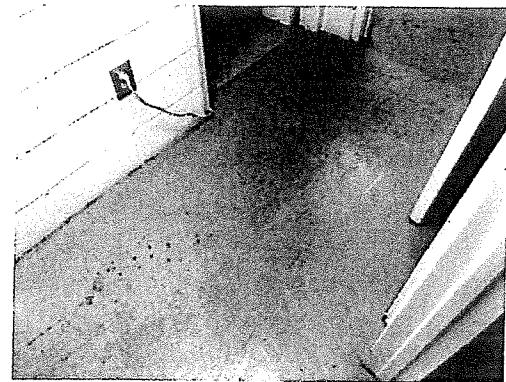
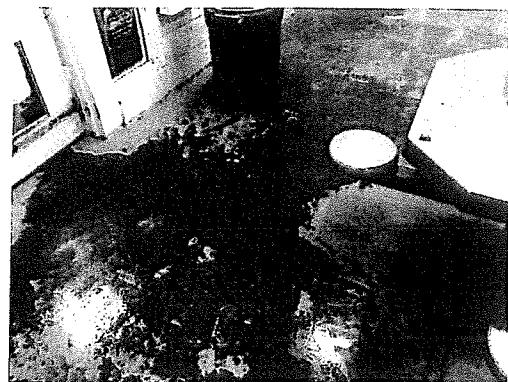
- A coating flooring system was utilized in most of the detention areas of the building. The County has replaced the flooring in Units #1, #2 and #3 with a similar system. Areas where the flooring has not been replaced, the coating system is showing signs of wear and needs replacement; these areas include the Lockdown Unit, Medical Holding, Laundry, Corridors, and miscellaneous detention areas. (Photo #15 and #16)

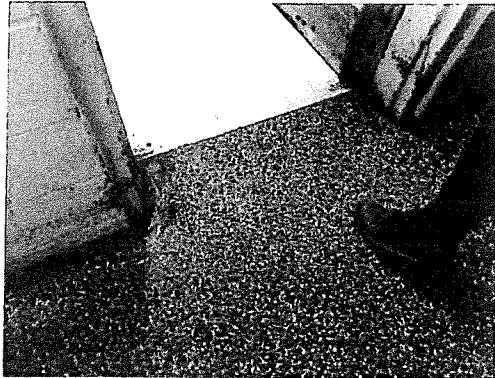
Photograph #17

- The East/West Unit, the North/South Unit, and the Female Unit are all located in the oldest portion of the building dating back to the 1970's. The flooring in these areas is terrazzo and is holding up well considering its age. (Photo #17)

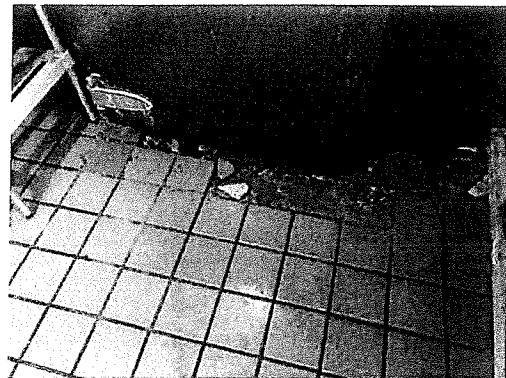
Photograph #18

- The kitchen flooring is quarry tile and has been damaged in the areas around the walk-in cooler/ freezer and should be repaired or replaced. (Photo #18)

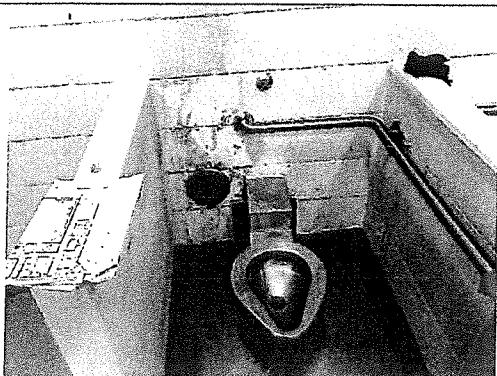
- Also, of notable concern are painted CMU walls at inmate toilets and shower areas. All these areas typically appear to be painted utilizing inferior products and/or the existing walls were not adequately prepped prior to the new paint being applied. All areas need to be repainted or another product/ system should be installed in these wet/ high-humidity areas. (Photo #21 and #22)

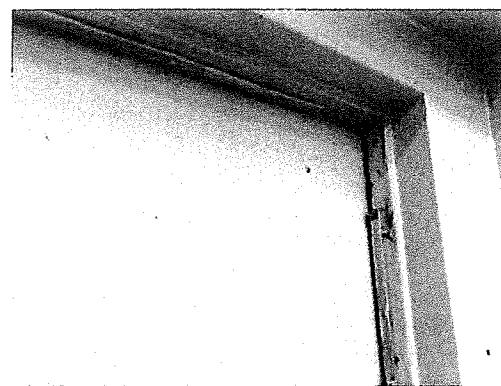
- In general, doors in the detention areas are showing signs of wear and age. All doors and frames need cleaning and repainting. Of notable importance, weather stripping installed at the doors from housing units #1 through #3 and the lockdown unit to the exterior rec yard is not detention grade weather stripping and should be replaced. The weather stripping is damaged in places and can be utilized by inmates as weapons. The Sheriff's staff reported that inmates have tampered with the door locks at these locations and in some cases have breached these doors. Further investigation needs to be made to determine if the existing doors, frames and hardware are in fact detention grade and if they should be replaced. (Photo #23 and #24)

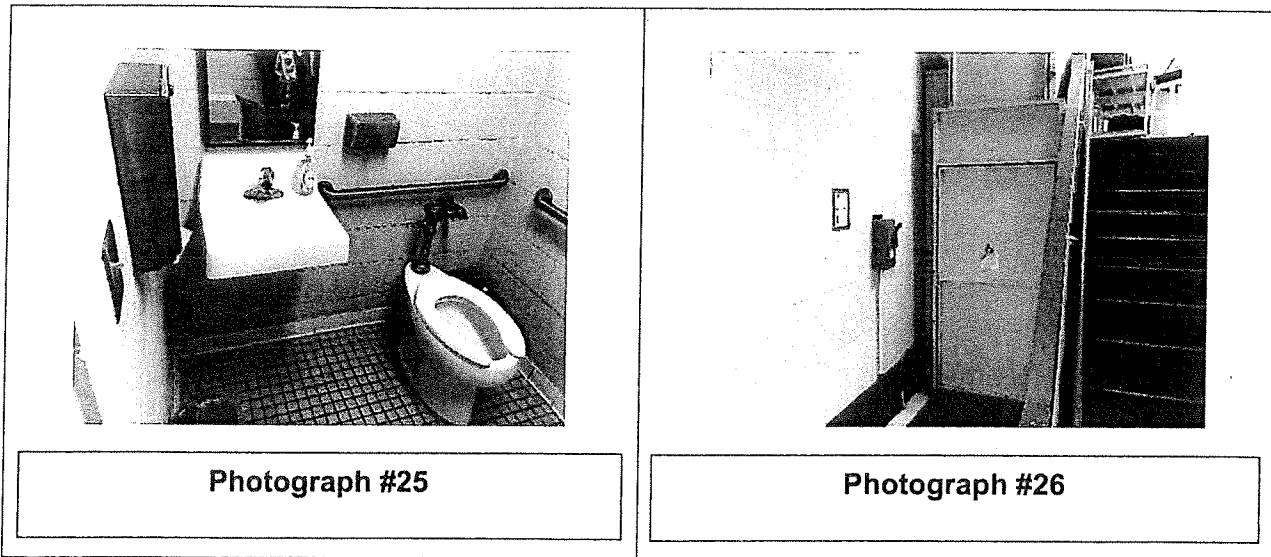
- In general, areas required to meet accessibility standards do not meet the current ICC A117.1-2009 ANSI guidelines, due to the age of the facility. No anti-ligature grab bars were observed. Some toilet rooms do not meet code required clearances. (Photo #25)

- Due to the varying floor heights in the building, a wheelchair lift and a service lift were installed. At the time of this observation the service lift was out of order. Maintenance staff reported the lift was scheduled to be repaired. During this observation meal deliveries were being made to housing units #1, #2, #3 and the lockdown unit. Staff and inmate workers were utilizing the wheelchair lift due to the service lift being out of order. The wheelchair lift was operating poorly and making a lot of noise. Staff reported the lift being problematic to operate and that meal delivery takes approximately 20 minutes to complete as only a single food cart can be loaded onto the wheelchair lift at a time. Both lifts are at or near the end of their service life and should be replaced. (Photo #26)

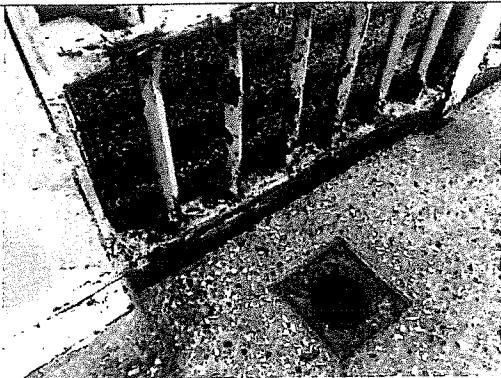
Photograph #32

- Evacuation route maps were not observed to be posted throughout the building.
- Fire extinguisher cabinets and sprinkler heads do not appear to be tamper-resistant type. (Photos #27, #28 and #29)
- Improper material appears to be used as firestopping material at electrical conduit penetrations. (Photos #30 and #31)
- Tamper-resistant steel detention doors and walls in the East/West, North/South, and Female Units in the original 1970's portion of the building have begun to corrode in places and need replacement. (Photo #32)

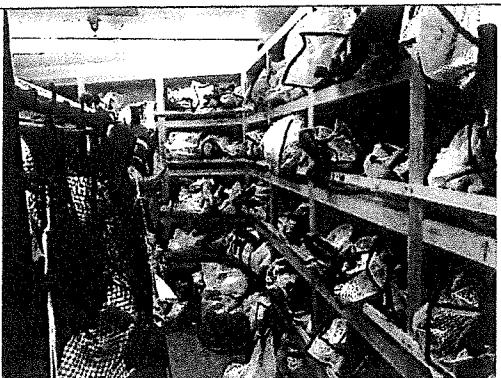
Photograph #33

- Inmate property storage room size and storage system is inadequate to support the needs of the facility. (Photo #33)
- Wall-mounted bunks in the Lockdown Unit do not appear to be adequately connected to the CMU walls. Expansion bolt connections rather than welded connections appear to be utilized and some of the bunks have been pulled off the wall. (Photo #34)

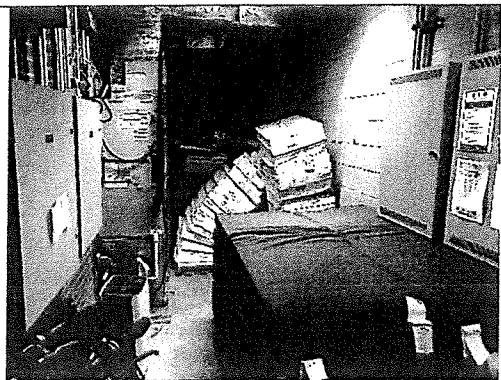
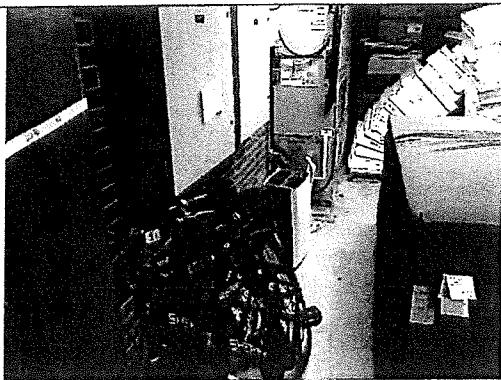
- Bulk material storage for the facility is inadequate. Bulk supplies, mattress, etc. are being stored in Room 124 which are impeding the code required clearances in front of electrical panels. (Photos #35 and #36)

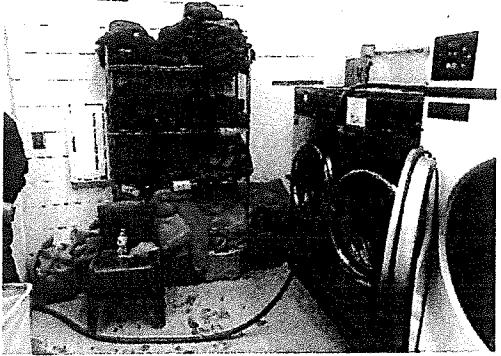
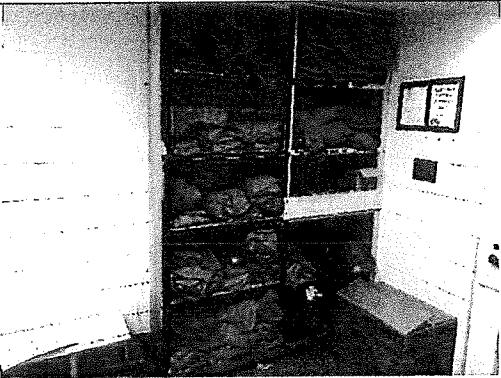
- Clean linen storage for the facility is inadequate. Items are being stored on shelving in the Laundry Room and Change-out Room. (Photos #37 and #38)
- Change-out facilities are inadequate. There is a single room which does not provide for separation of males and females. Change-out room does not provide toilet or showers.

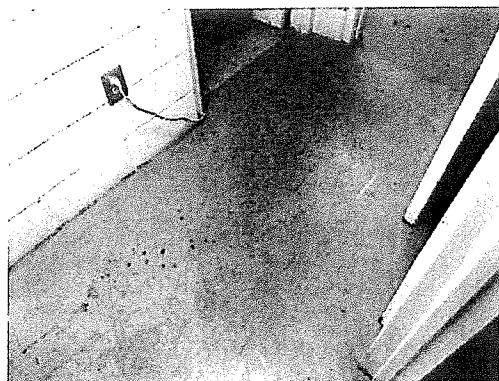
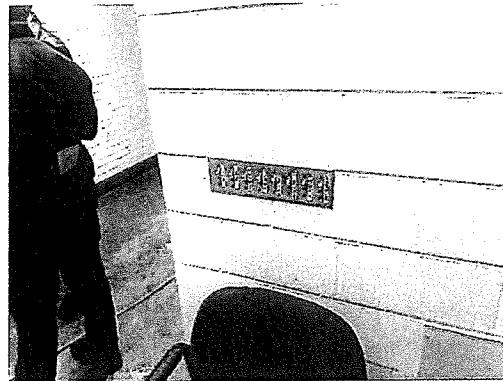
- Electrical outlets and switches do not have detention covers. (Photo #39 and #40)

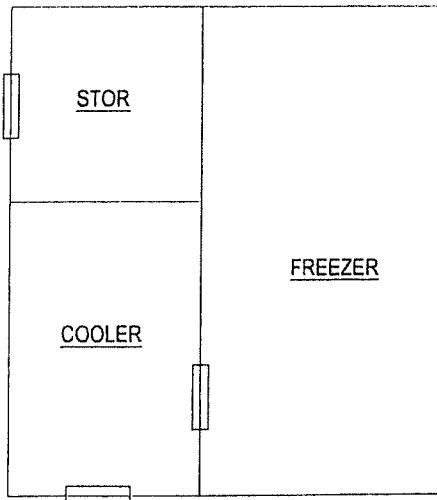
EXISTING

220 x 1.2 = 264 square feet. The existing cooler freezer is about 320 square feet total, so the overall size is adequate. However, the ratio between freezer and cooler should be 45% cooler and 55% freezer. The current ratio is about 30% cooler and 70% freezer. Since the cooler and freezer assembly is scheduled to be removed and replaced, we suggest the following change to correct the ratio and provide more perimeter wall separation to correct mold formation problems.

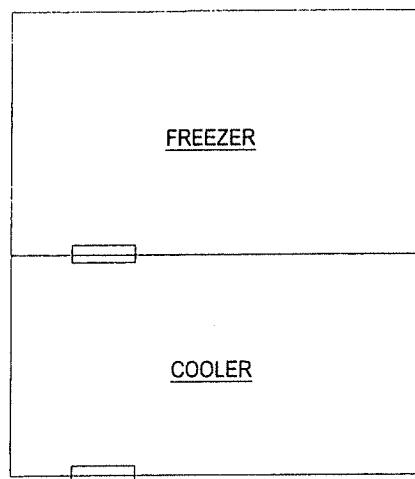
PROPOSED

- Expand the overall cooler freezer footprint to capture the small storage room space.
- Reduce the overall width and length by 11.5" in each direction to increase offset from building walls.
- Rotate the direction of the cooler and freezer one behind the other to allow alignment of doors.
